Det.nr	Ant	Benämning	Material	Dimension	Anmärkning			
	Ritad/Konstr	Ansvarig	Kontr	Stand	Godkänd	Skala	Ersätter	Ersatt av
	U.C	AR						
Beskrivning							Datum	
1B Outward opened. Double Door							220214	
UL.ULN							Ritning.nr	
							100-5-419

Beskrivning Section of glazing 2B		Datum 220214
							Ritning.nr 100-5-419

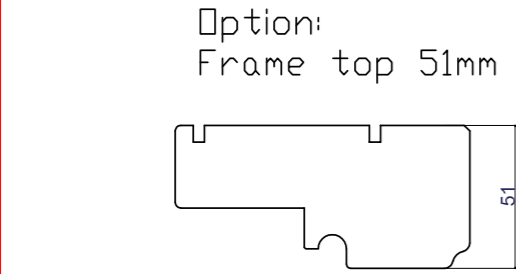
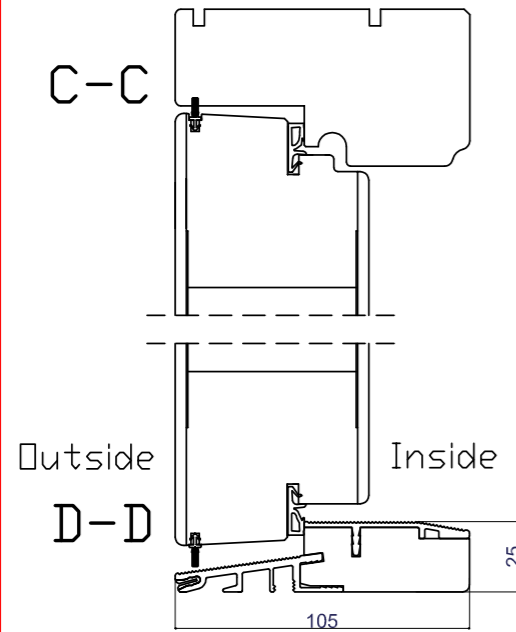
Option:
Reveal lining on
threshold

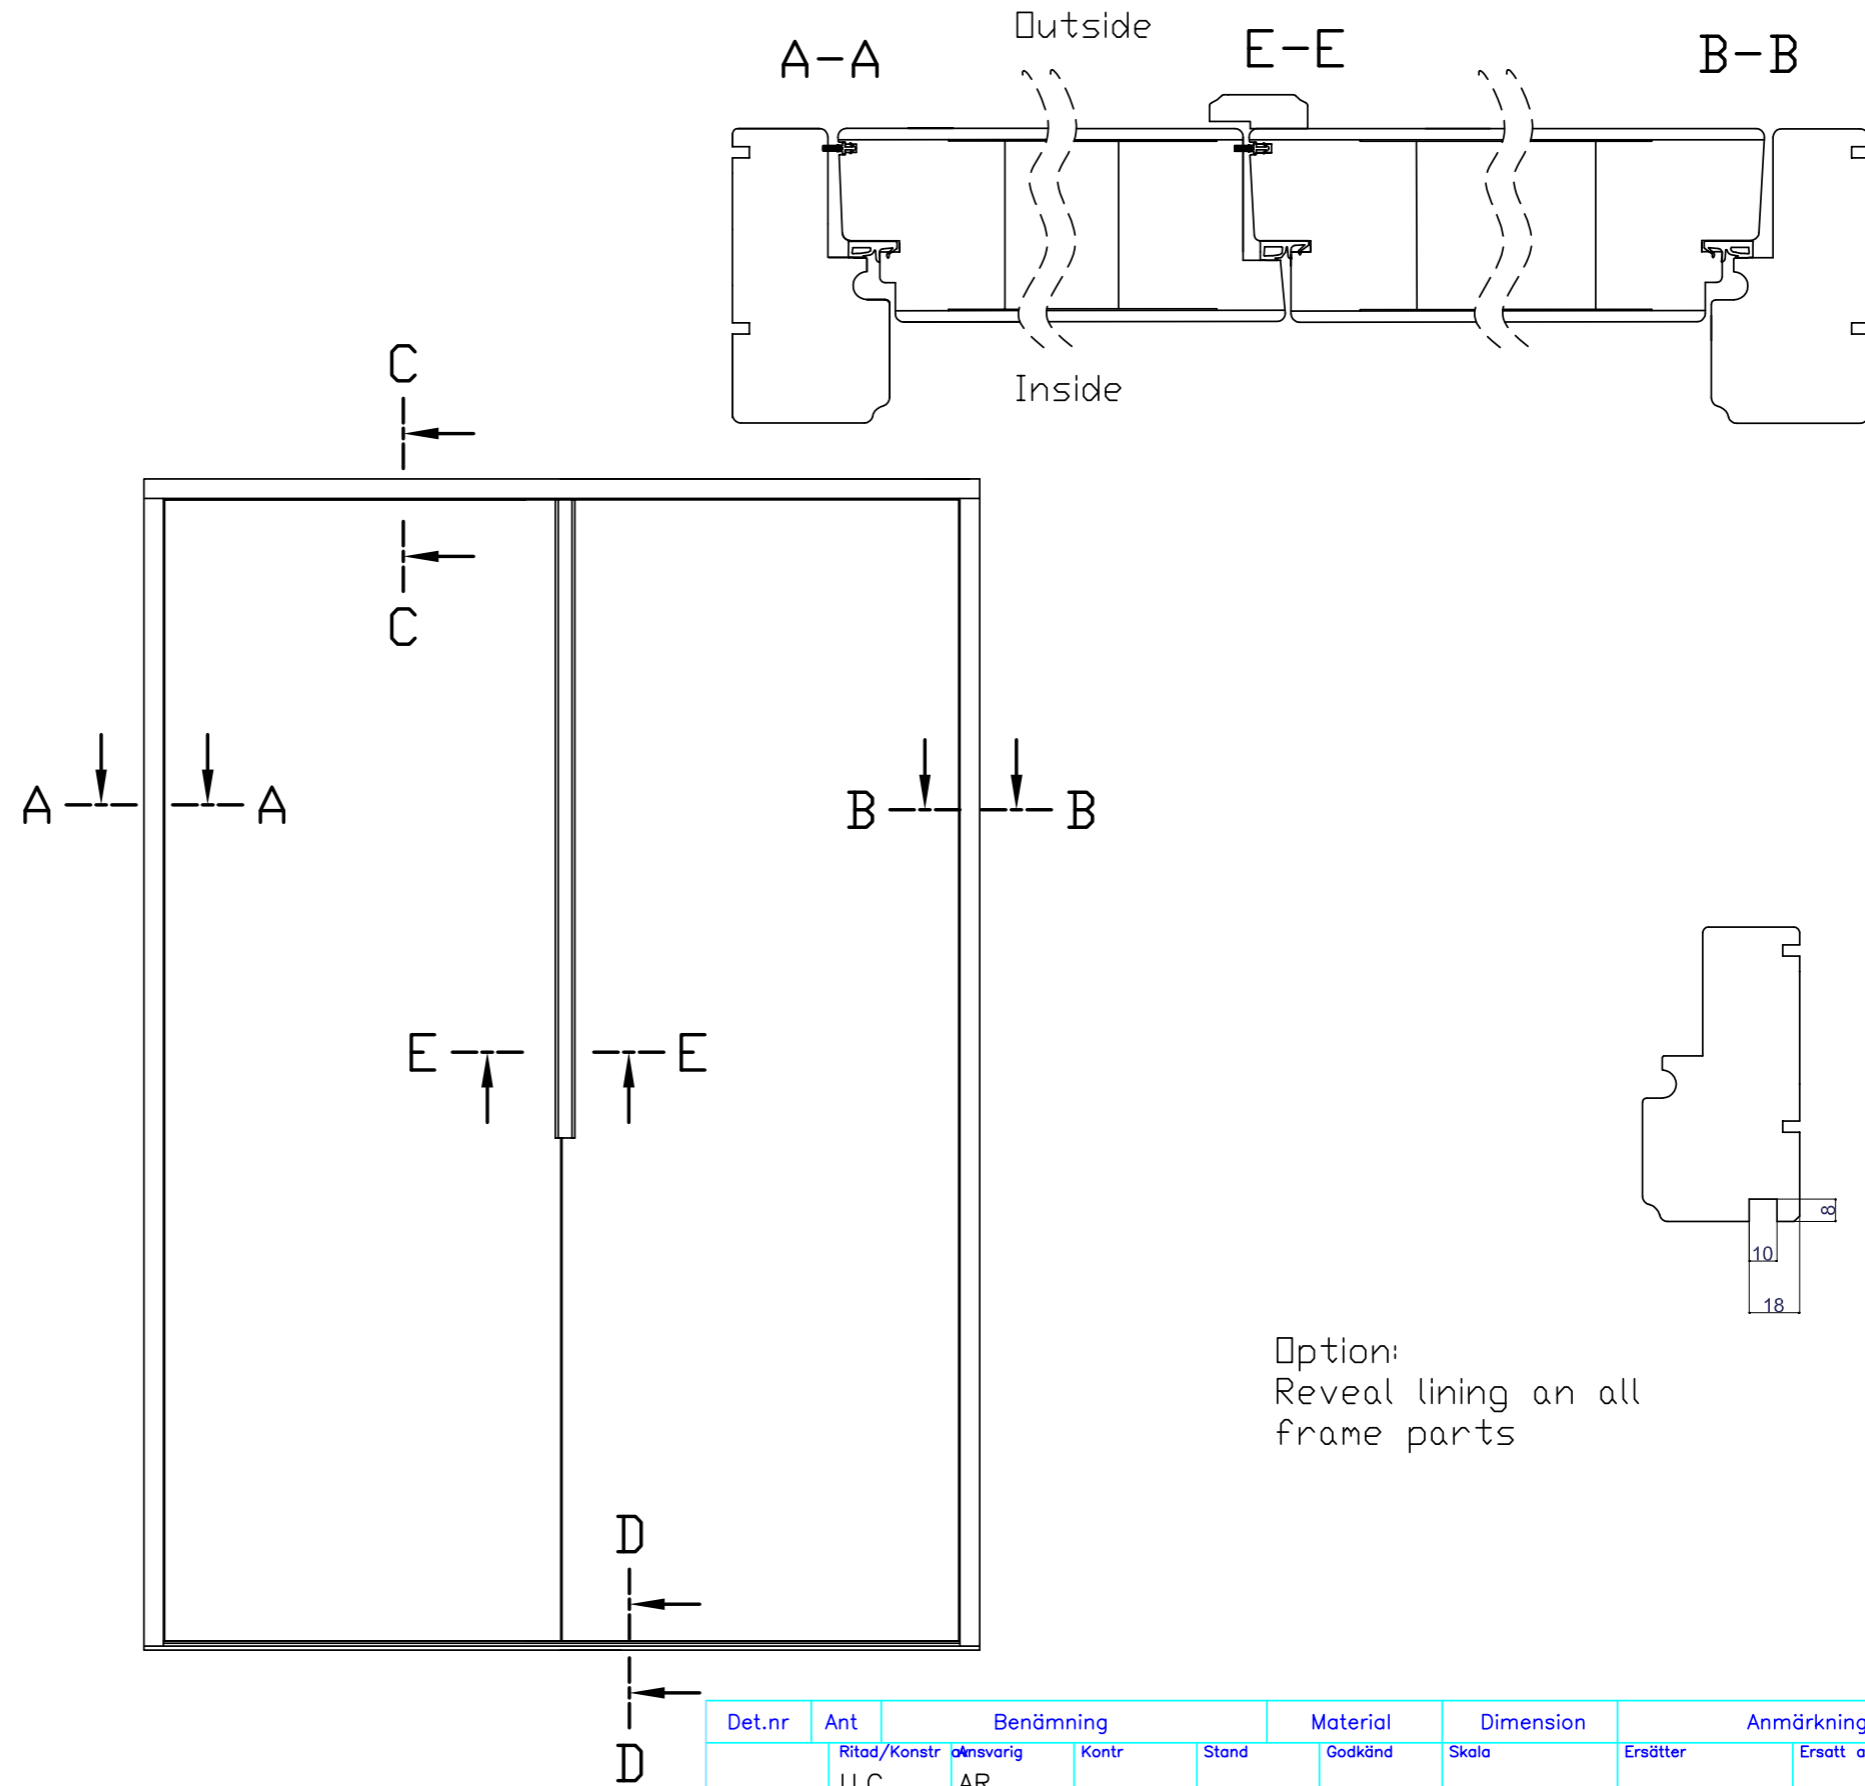
Option:
Reveal lining on all
frame parts

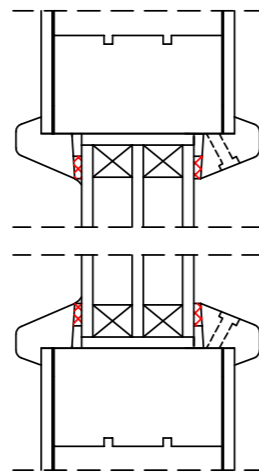
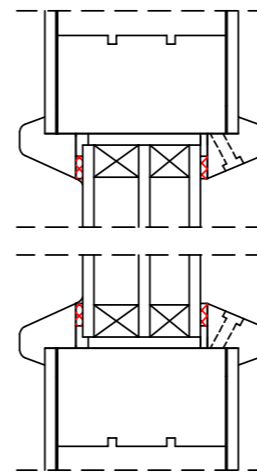
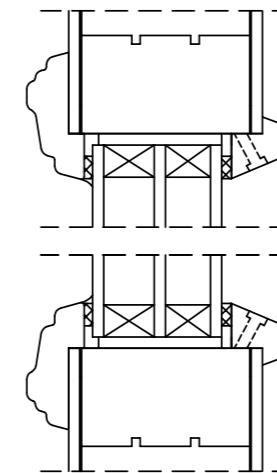
Vertical

Horizontal and vertical section of glazing of door leaf Outside <- Glass -> Inside

834PG, 835PG, 871PG, 992PG, 869PG2+1

819PG, 831PG2, 836PG, 838PG,
302PG2+1, 836PG1+3, 839PG1+3,
836PG3, 839PG3

820PG, 843PG, 892PG
